Technical Service Bulletin

01 MIL on (P0491 and P0492 stored at same time)

01 17 01 2033001/10 February 13, 2017. Supersedes Technical Service Bulletin Group 01 number 16-81 dated October 13, 2016 for reasons listed below.

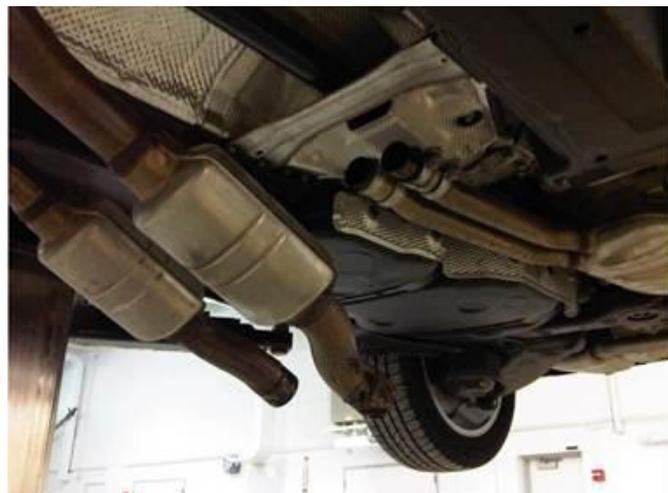
Figure 7. Lowered catalytic converter pipes.

1. Move the exhaust sliding bushings (that connect the catalytic converter and muffler) back, then lower the catalytic converter pipes (Figure 7).

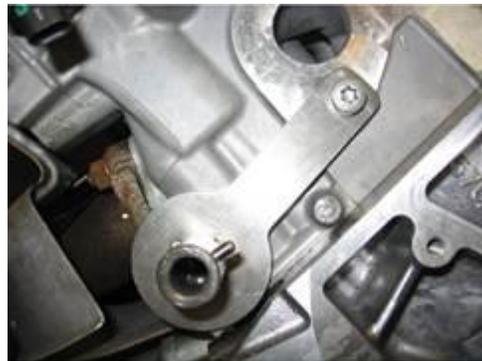
Figure 13. Engine adaptor on bank one.

2. To catch water, put a pan under the front of the engine and under the disconnected catalytic converter pipes.
3. Install engine adaptors on the appropriate banks (Figure 13 and Figure 14).

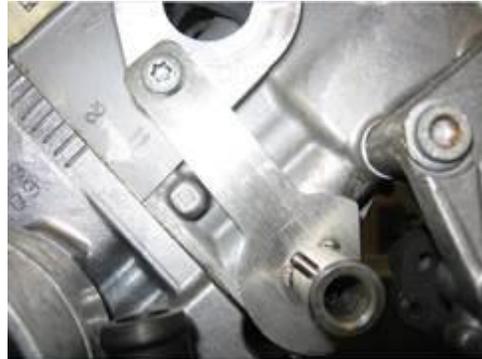
Figure 14. Engine adaptor on bank two.

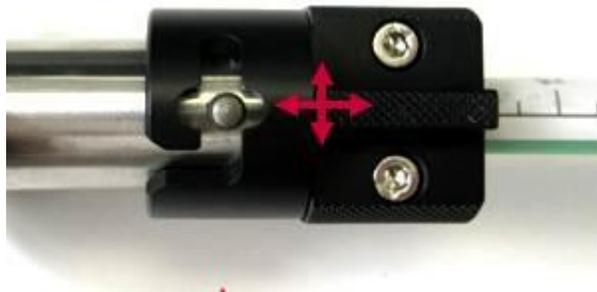
Figure 16. Locking position / transvers longitudinal movement and of the hose adaptor

- After adjusting the position of the hose adaptor, insert the special single port cleaning hose into the hose adaptor, and bring it back into locking position (Figure 16).

- While cleaning, make sure that the pressure washer is supplying pressure greater than 1800 psi.
- Based on the washer's pressure, clean the port based on the table below. While cleaning, continuously move the hose adaptor within the longitudinal and transvers slots (Figure 16).

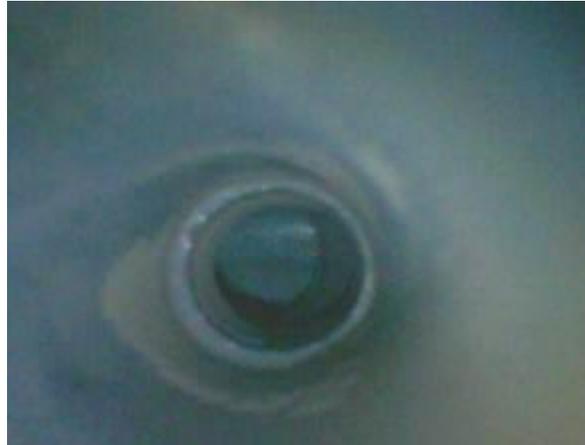
Figure 17. Clean single port.

6. It is recommended that after cleaning, all single ports are checked with snap-on boroscope BK6000 (or similar, with 90-degree lens), to make sure all ports are clean (Figure 17).
